Case Study

Royal Cornwall Hospital Treliske, Truro Pharmacy Dept

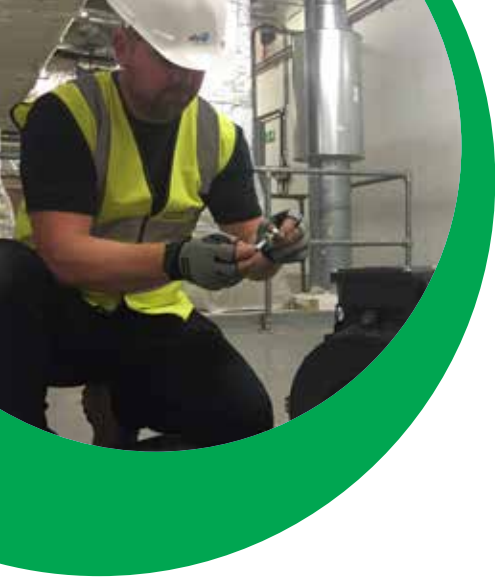
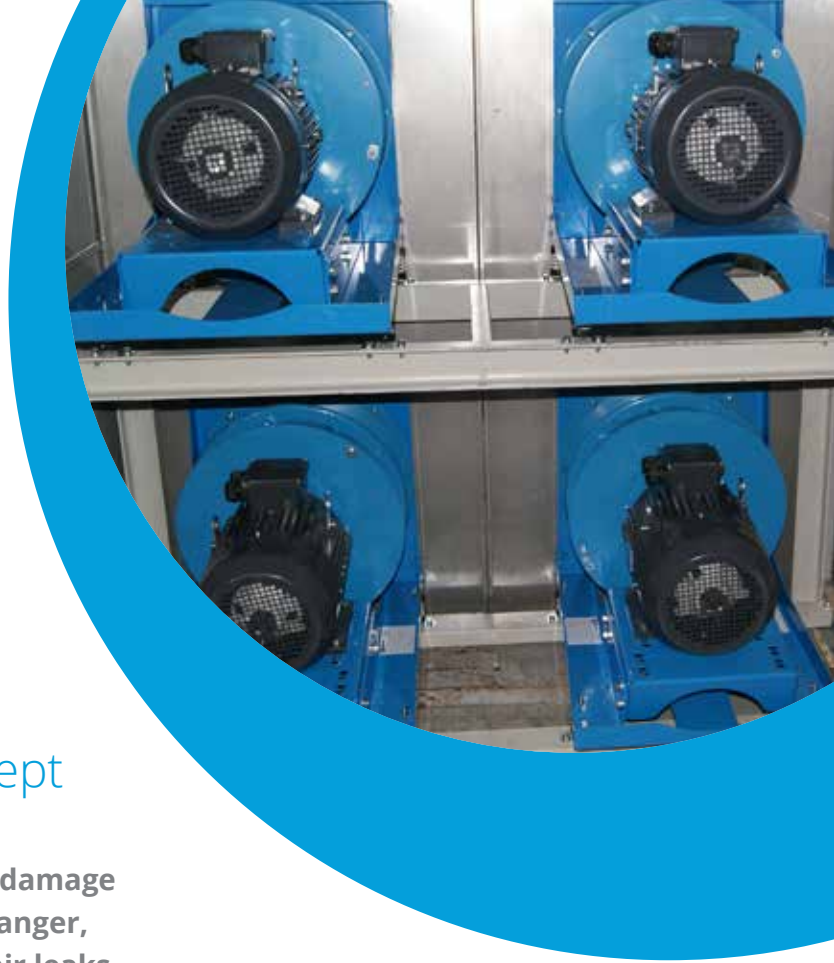
A large air handling unit with corrosion damage to the intake, collapsed plate heat exchanger, clogged heating and cooling coils, case air leaks and deteriorating fans with motors out of airstream.

The heat exchanger had collapsed due to the high differential pressure between supply and extract airflow. Due to limited access the inlet louvre, silencer and ducting had to be removed to facilitate the refurbishment.

The inlet section, damper, frost coil, filter section were stripped out and replaced with new components and panel plating. The two supply fans were removed and replaced with direct drive centrifugal 'plug' fans complete with inverters. This enabled the duty of three fans to be ramped up to maintain the duty in the event of one failing. The plate heat exchanger was replaced with a new unit capable of high differential pressure.

Once works completed the AHU was chemically deep cleaned and a photographic report provided. The works were done predominantly over a weekend to minimise inconvenience in the building served.
