Case Study

Supermarket, Gravesend

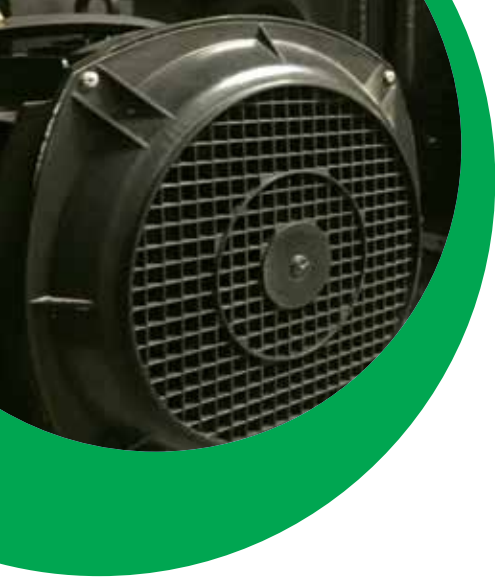
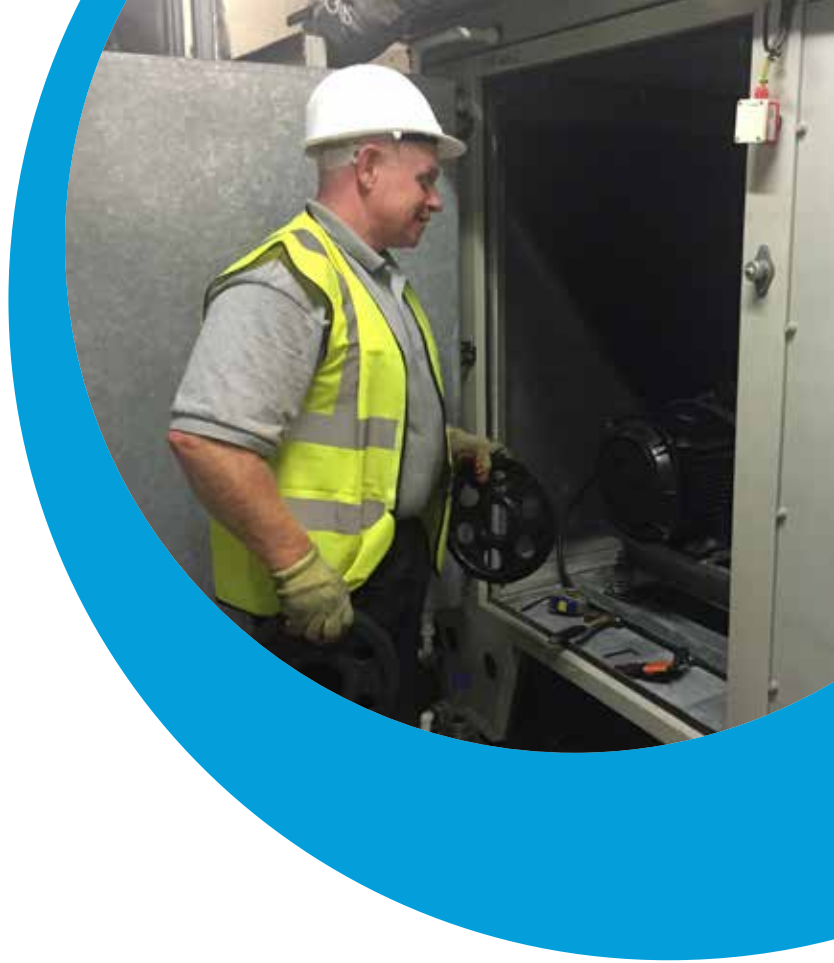
The bearings on a large backward curved fan collapsed causing the complete failure of the fan, and damaging the flexible connection and AV mounts.

AHS Specialist Services had to cut up the fan in situ to remove it, and provided a new fan in split case format for the replacement due to limited access. New AV mounts, new motor, bushes, pulleys, belts and flexible connection were also installed.

Due to the size of the components a stair walker had to be used to get the components to the plantroom. AHS Specialist Services left the new fan running, and removed all scrap from site within a two day window.
