Case Study

Science Park

2x Large AHUs (12m³/s)

EC fan wall upgrade c/w refurbishment
of the AHU

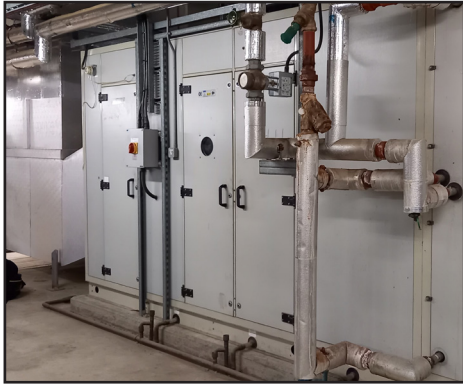
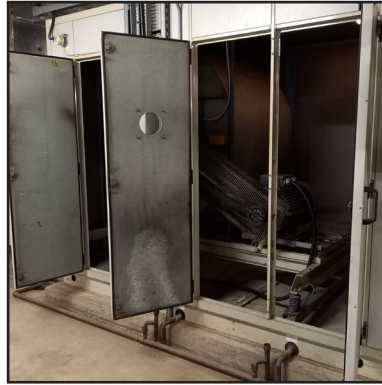
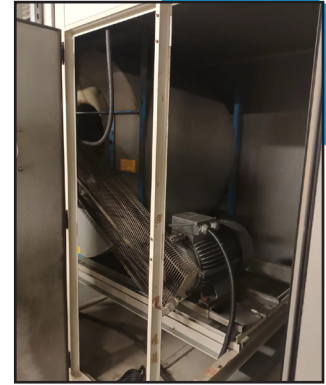
Before Upgrade

The existing units were fitted with a single, large backward curved fan and motor that was nearing the end of its lifespan.

Works completed were an EC fan upgrade to reduce both energy and maintenance cost, treatment of the floors and chequer plating due to the requirement for maintenance access, new frost coil and new filter frames.

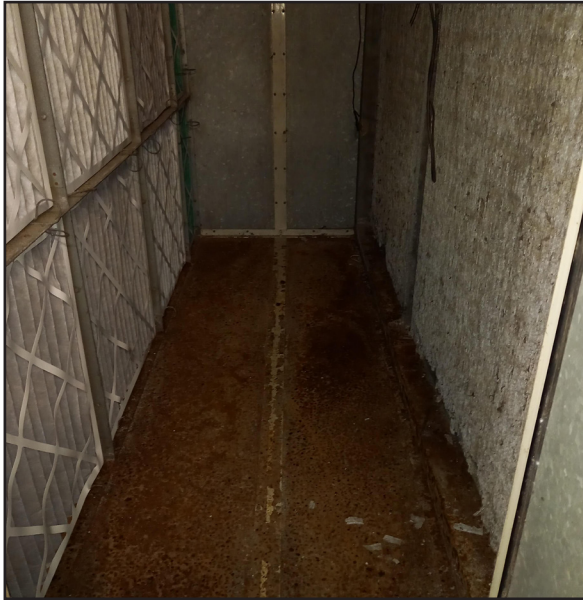
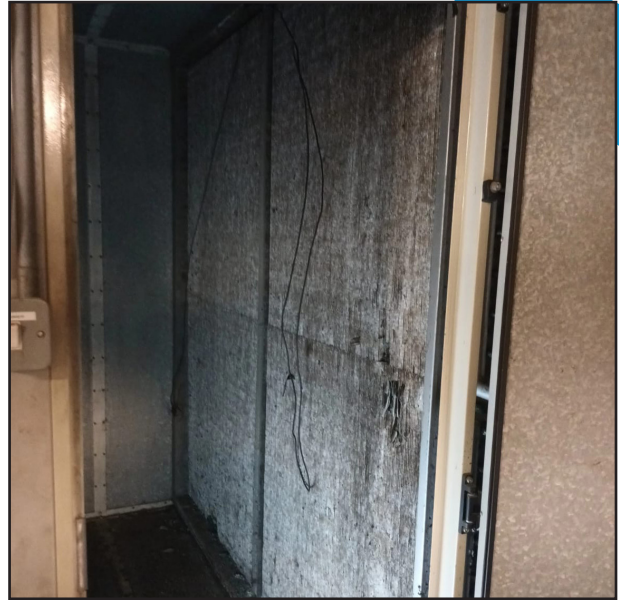
The inlet section containing the frost coil and filters was in poor condition with heavy, but treatable surface corrosion on the floor.

Inlet section before upgrade

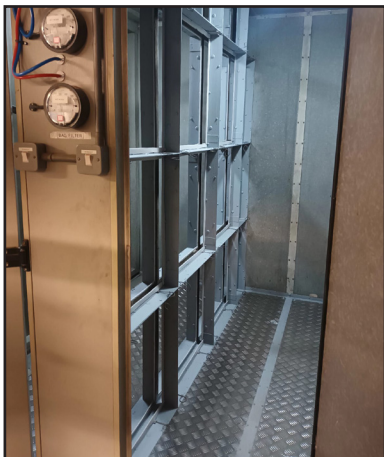
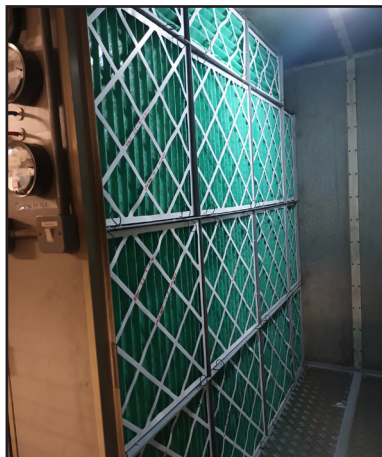
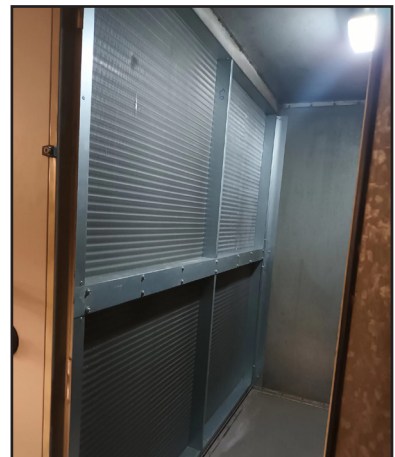
New coil, filter frames and corrosion treatment completed
